# Monitoring and Evaluation Plan for Two Coastal Erosion Options for Eastern Tongatapu, Tonga

**SPC – GCCA:PSIS**

**eCoast**

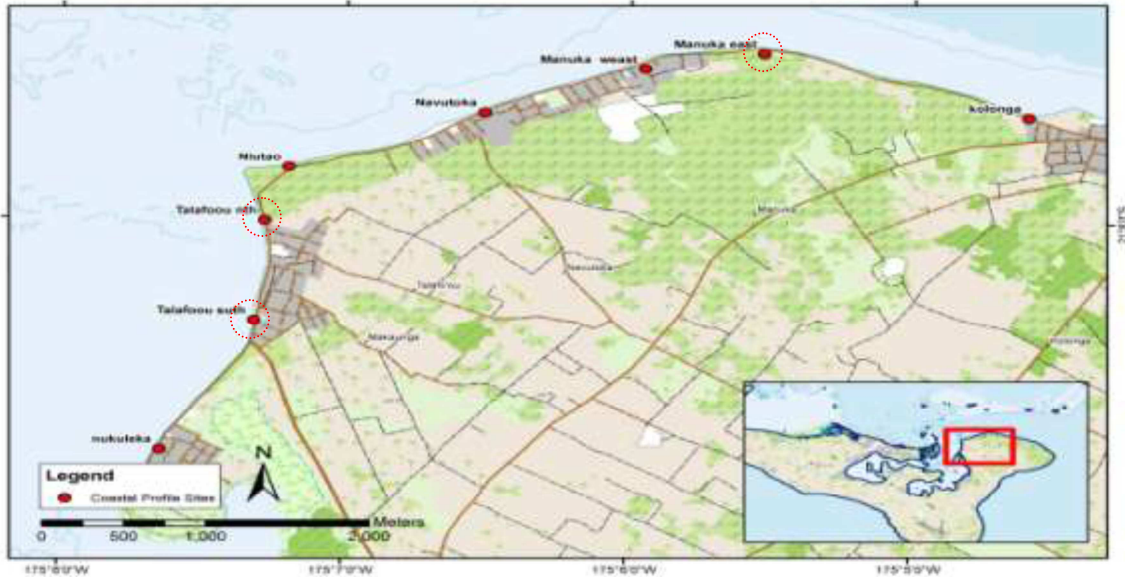
Fortunately some existing beach profile data is available for the area, with profiles both within the trial areas (Impact) and outside these areas (Control). The first set of beach profiles were measured in May 2012, and 9 sites from Kolonga to Nukuleka

(Figure 2.1), 3 of which are within the trial areas – 2 at Makaunga/Talafo’ou, and 1 at eastern Manuka (Figure 2.2). Thus, there are 6 Control sites and 3 Impact sites that have Before data.

Figure 2.1. The 9 beach profile sites in the study area – 3 are within the trial areas.

Monitoring of all three sites (Figure 2.3, Figure 2.5 and Figure 2.7), including the 6 existing profiles outside of the study sites (Figure 2.1), will be undertaken at the following intervals:

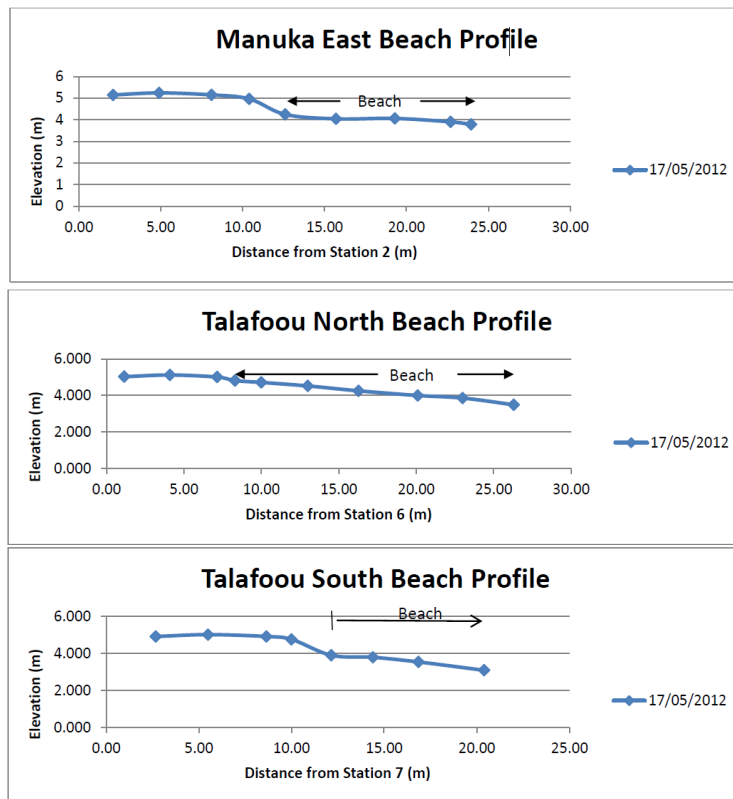
Figure 2.2. Beach profiles within the trial sites.

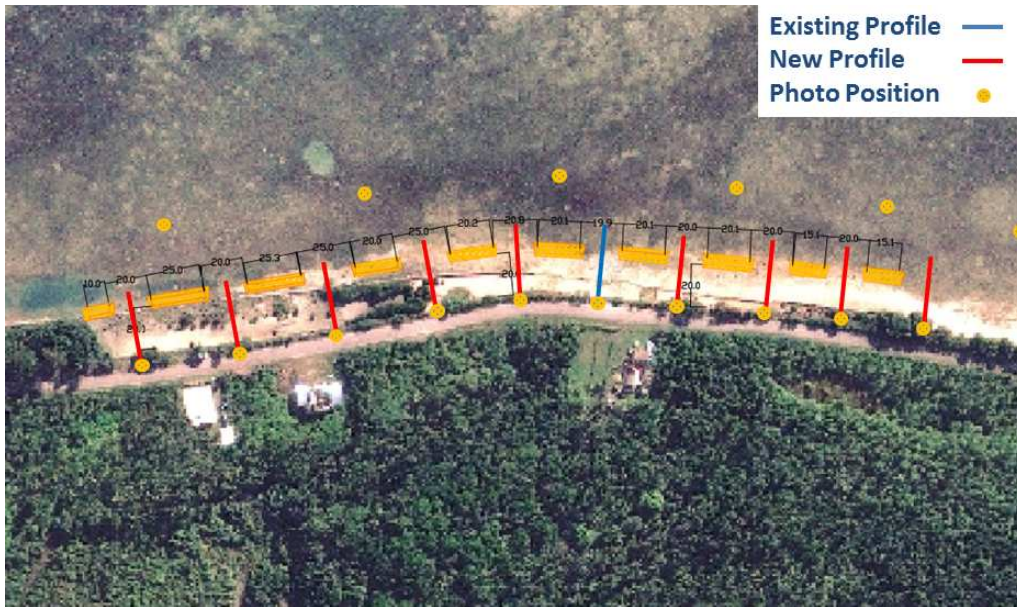
At Eastern Manuka, 10x 35 m long beach profiles will be monitored, with 15 camera locations (Figure 2.5). Beach profiles will be taken midway between detached breakwaters, as well as one to the east of the trial site. Photographs will be taken from the landward end of the beach profiles, as well as at 5 offshore sites looking landward towards the structures (Figure 2.6).

Figure 2.5. Beach profile and camera/photograph locations eastern Manuka.

Field notes will be taken for each detached breakwater and provide short comment on both the structure's integrity and the beach response. A hand-held GPS will be used to record the location of each beach profile and camera position and given an appropriate number (e.g. beach profile numbers from 1-10 from west to east).

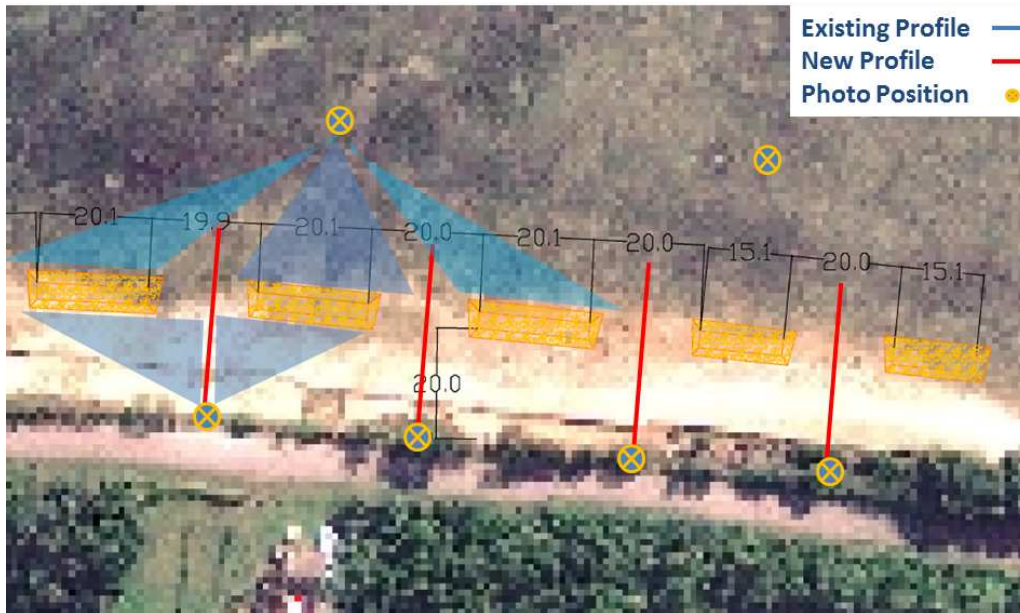
Figure 2.6. Camera shot angles from the landward end of each beach profile and from offshore looking landward towards each detached breakwater.

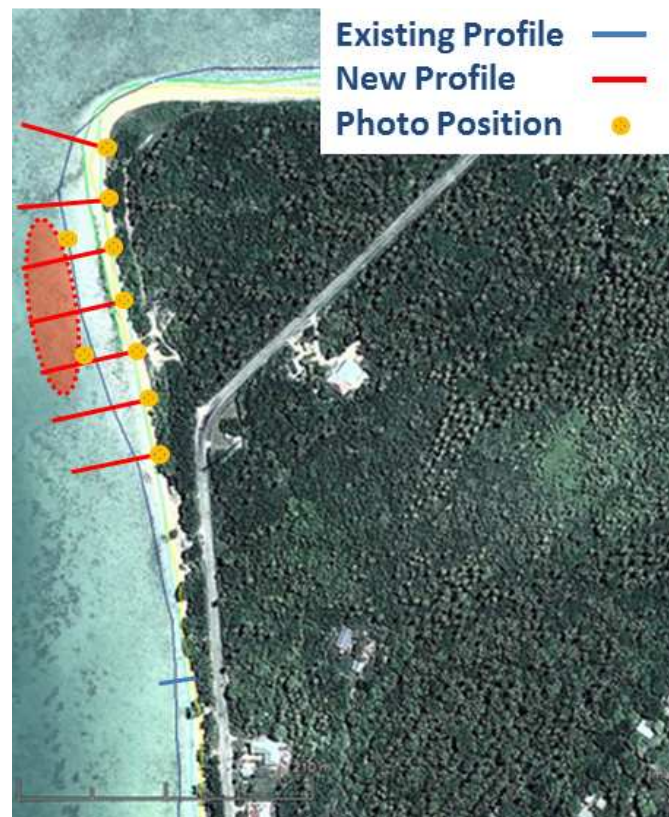
At the Borrow Site, 7x 50 m long beach profiles will be monitored, with 9 camera locations (Figure 2.7). Beach profiles will be taken at 30 m intervals along the borrow site, and extend across the excavation area (Figure 2.7). Photographs will be taken from the landward end of the beach profiles, as well as at 2-3 offshore sites to visually record the extent of the excavation.

**Figure 2.7. Beach profile and camera/photograph locations at Whitehouse Point.**

Field notes will be taken for each beach profile and provide short comment on both the observations of the borrow area and the beach response. A hand-held GPS will be used to record the location of each beach profile and camera position and given an appropriate number (e.g. beach profile numbers from 1-7 from south to north).
